Date: June 18, 2008
From: Moto Guzzi USA
To: All Moto Guzzi Dealers

Service Communication: 2008-002 USA Flag Designation

Subject: Safety Recall Campaign- Norge 1200 accessory top case mounting bracket.

Affected model: Norge 1200 with accessory top case fitted.

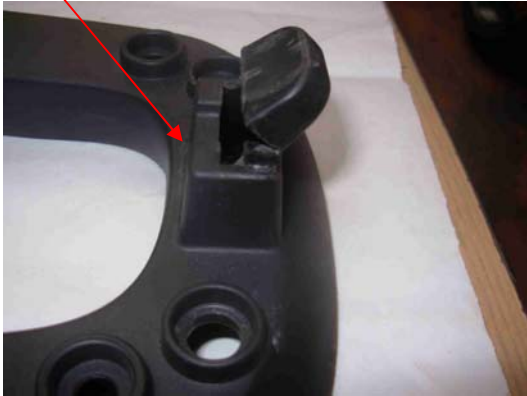
DEFECTIVE BRACKET

Concern: The mounting bracket that supports the top case can break, leading to a possible detachment of the top case. Since this is an important safety concern, it is important to identify and rectify any defective mounting brackets, either in dealer stock or with your customers.

- 1) Plastic bracket with no latch reinforcement- DEFECTIVE-DO NOT USE
- 2) Plastic bracket with metal latch reinforcement.- O.K. TO USE

Parts Information: Brackets that have the metal reinforced latch do not need replacement. Any brackets that do not have the metal reinforced latch will need to be replaced. The new recall bracket has a continuous metal arc support at the rearmost section in addition to an aluminum latch. The plastic covering is pre-installed. Please order this new part through the BM ordering system. Any defective brackets, either from customer bikes or dealer stock, must be returned to Moto Guzzi USA.

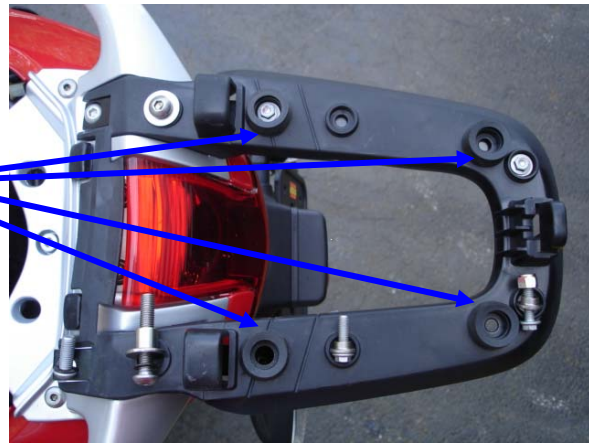
- 1) Remove defective plastic latch with left and right metal supports

Save the 4 rubber cushions

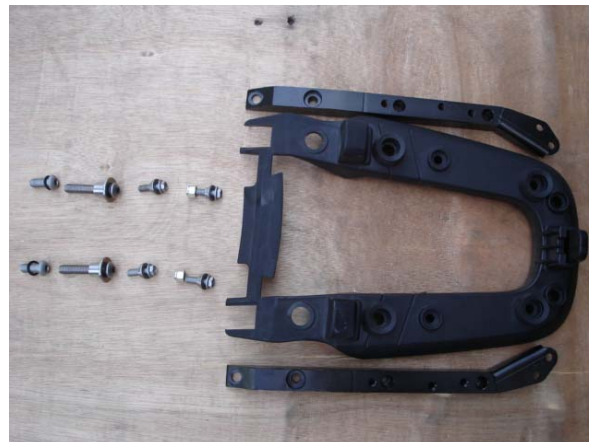
- 2) Photo of removed components
Save bolts/screws

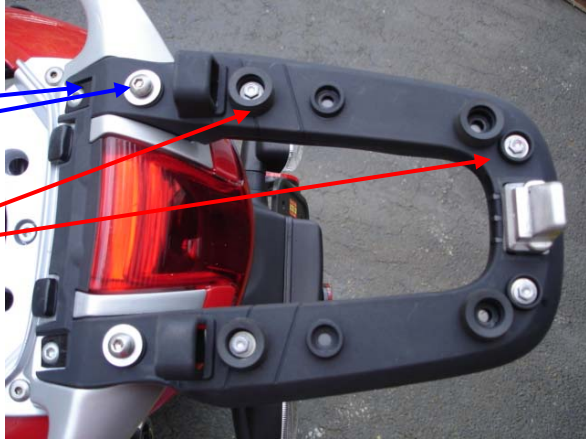
- 3) Fix new bracket 883147- reusing bolts

Torque to 18 ft. lbs.
(Repeat for opposite side)

Torque to 9 ft. lbs.
(Repeat for opposite side)

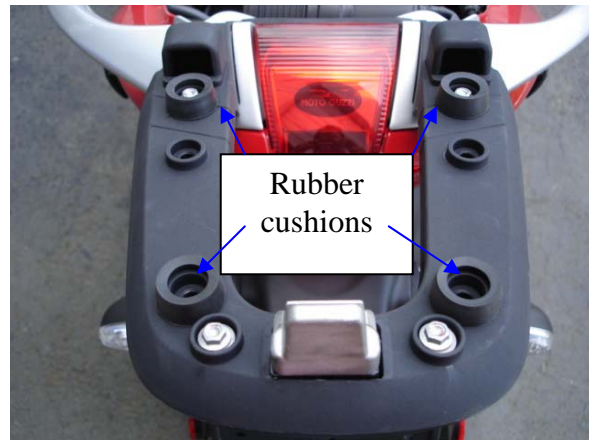
- 4) Photo of new bracket with rubber cushions
