TECHNICAL NOTE No. 001-2005

**MODEL: V11 Ballabio – Cafè Sport – Cat 2003-2005**

**SUBJECT: New tachometer cable**

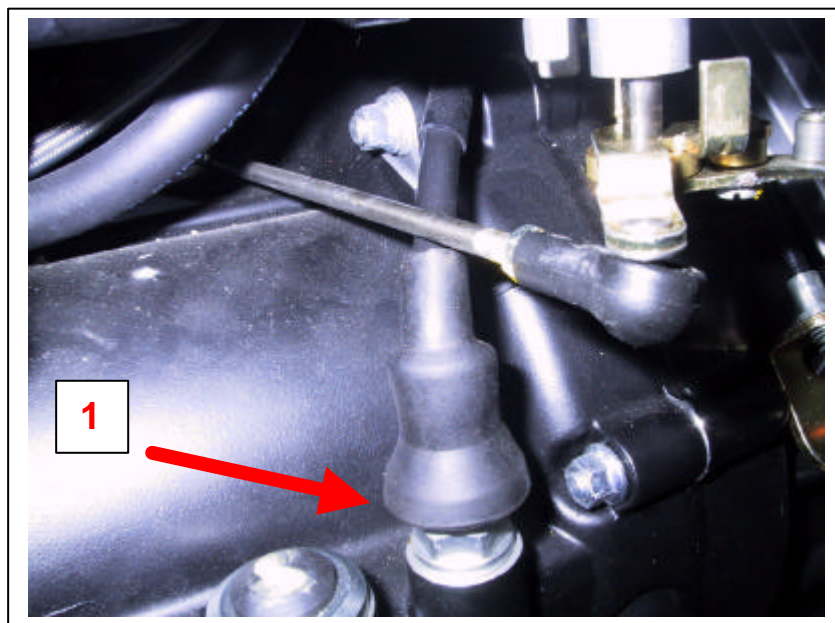
Picture 1

We have ascertained that on the above vehicles, that are equipped with the return cable for the throttle cable (part no. 01603380), the tachometer cable might break due to the angle with which it is fixed to the engine (1). (Picture 1)

In case the cable needs replacing, spare new cables are available part no. 01760481 (supersedes part no. 01760480) and part no. 01760492 (supersedes part no. 01760491), that are fitted to the engine at a wider angle (20°).
