Re: Recall campaign: Cardan unit Brevia 1100, Griso 1100

Through our ongoing technical controls for improving the products we have ascertained the possibility that some Brevia 1100 and Griso 1100 machines may have a problem in the rear transmission box, with oil leaking and dirtying the rear wheel.

C.A.R.C. DRIVE ASSEMBLY REPLACEMENT PROCEDURE

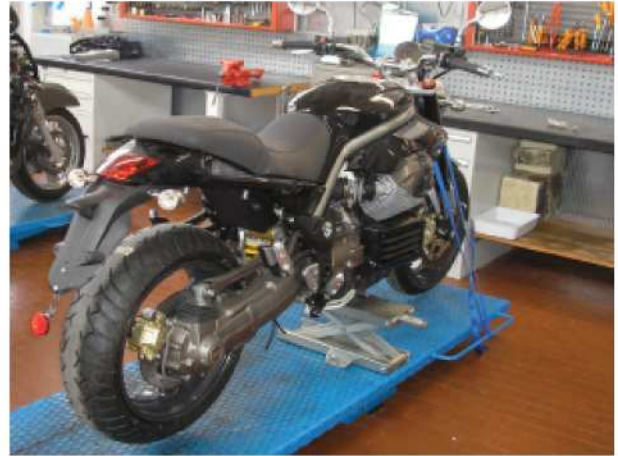
- Support the vehicle using a lift and secure it with slings to make sure it is stable.

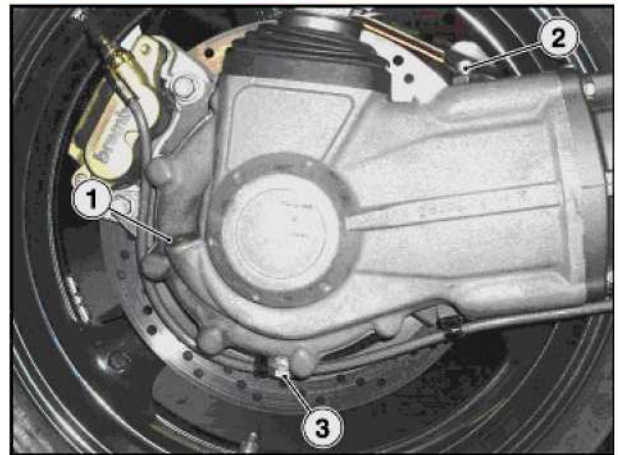
- Place a container capable of holding more than 500 cc (30.5 cu. in.) under the drain plug (3).
- Unscrew and remove the drain plug (3).
- Unscrew and remove the breather plug (2).
- Let the fluid drain into the container and allow several minutes for the fluid to drip off.
- Refit and tighten the plugs (1), (2) and (3)

Tightening torque for screw (1): 35 Nm

Tightening torque for screw (2): 30 Nm

Tightening torque for screw (3): 30 Nm

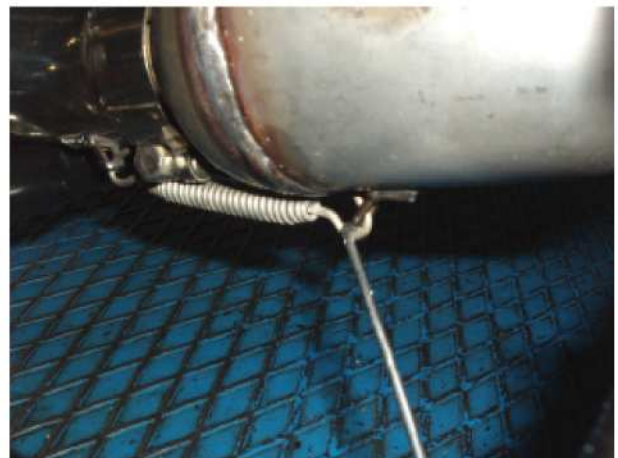
- Remove the spring attached to exhaust and central manifold using a suitable spring removal tool.

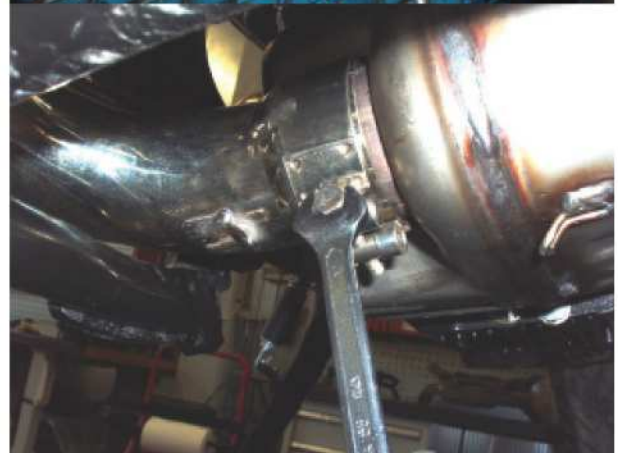
- Slacken the clamp attached to exhaust and central manifold.

Note for reassembly: Tightening torque: 10 Nm

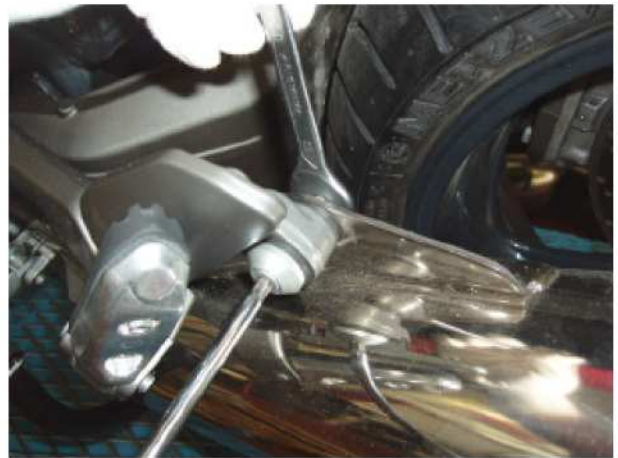
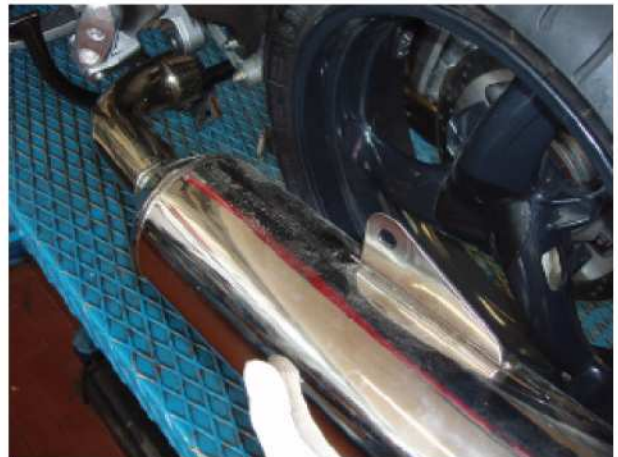
- Unscrew and remove the screw securing the exhaust to the frame and collect nut, spacer and washers.

- Remove the exhaust.

Note for reassembly: Tightening torque: 25 Nm

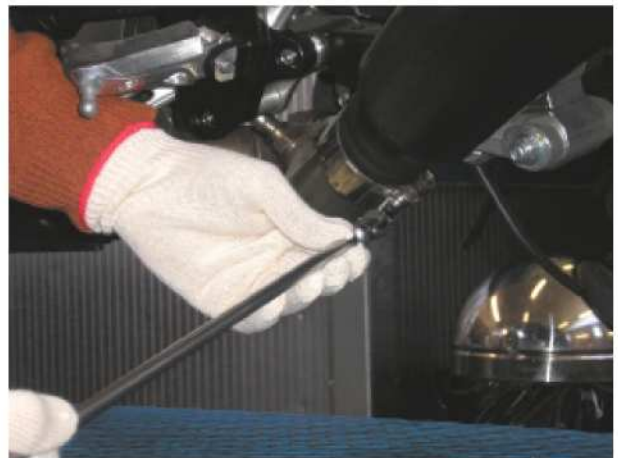
- Slacken the clamp attached to exhaust and central manifold.

Note for reassembly: Tightening torque: 10 Nm

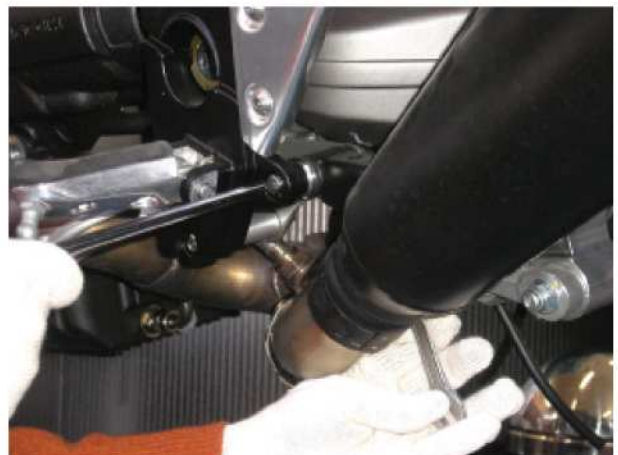
- Unscrew and remove the two screws securing the exhaust to the frame at the front end and collect the nuts.

Note for reassembly: Tightening torque: 25 Nm

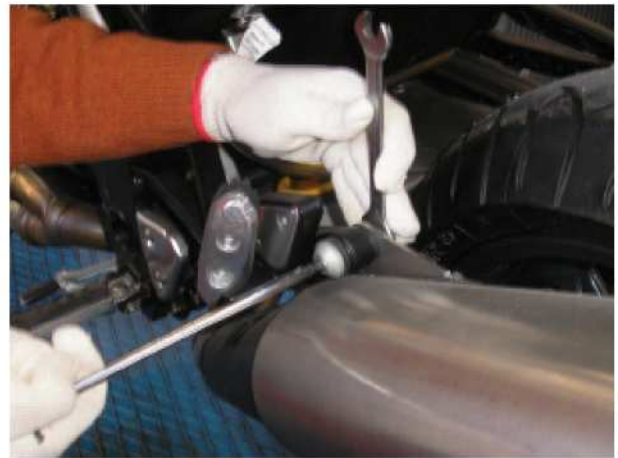
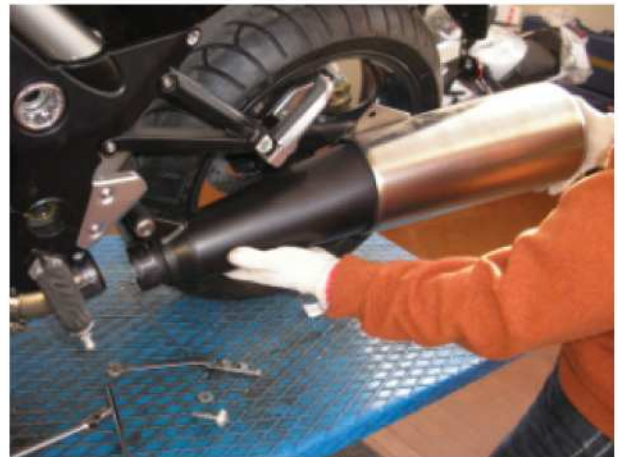
- Unscrew and remove the screw securing the exhaust to the frame at the rear end and collect nut, spacer and washer.

- Remove the exhaust.

Note for reassembly: Tightening torque: 25 Nm

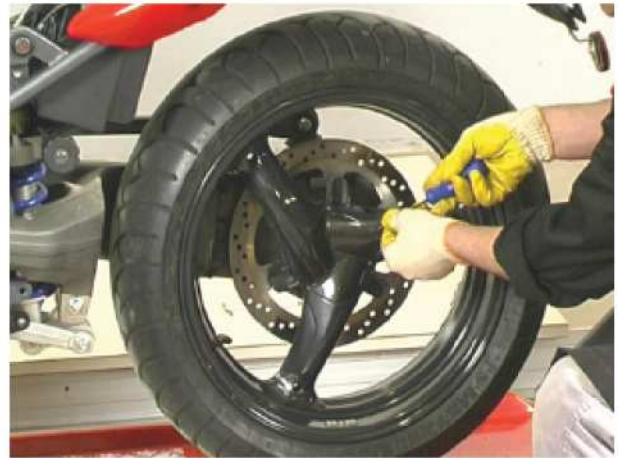
- Remove the cover.

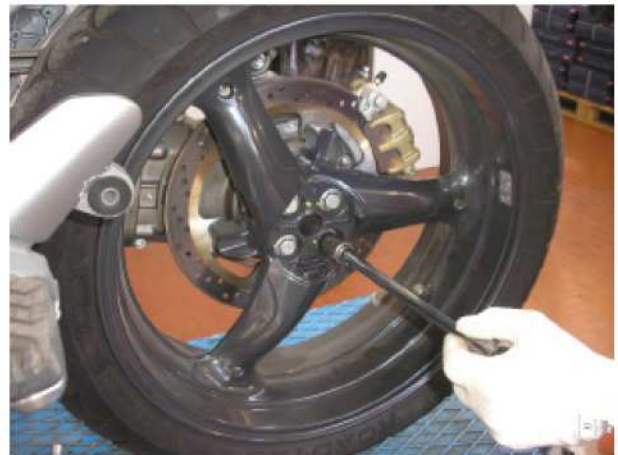
- Operate the rear brake lever and **slacken** the four mounting screws of the rear wheel.

Note for reassembly: Tightening torque: 110 Nm

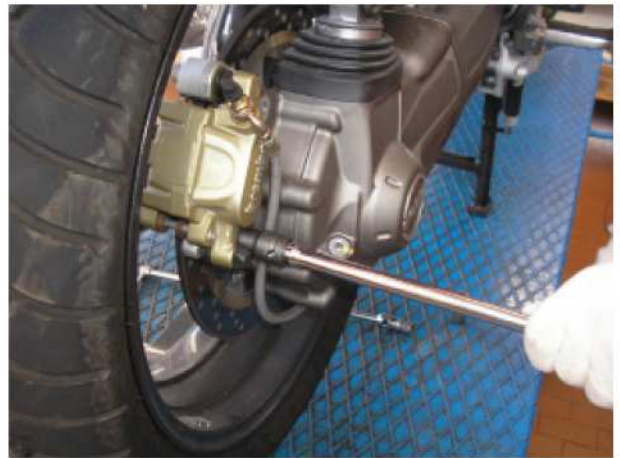
- Unscrew and remove the two screws.

Note for reassembly: Tightening torque: 50 Nm

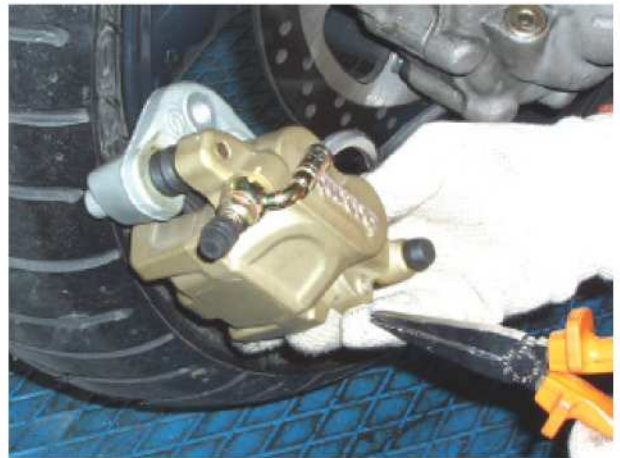
- Remove the brake calliper using great care and leave it attached to the brake hose.

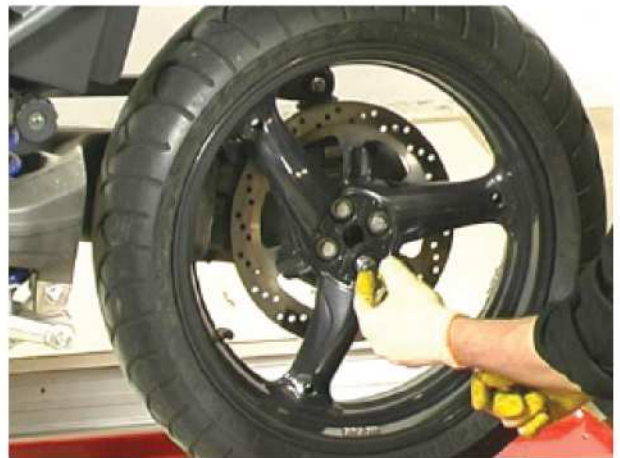
- Unscrew and remove the four rear wheel mounting screws.
- Remove the rear wheel.

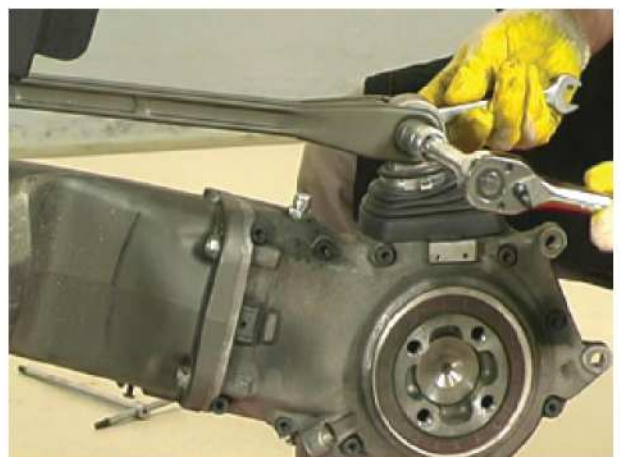
- Unscrew and remove the linkage nut.
- Remove the screw.
- Secure the linkage to the frame using a tie.

Note for reassembly: Tightening torque: 50 Nm

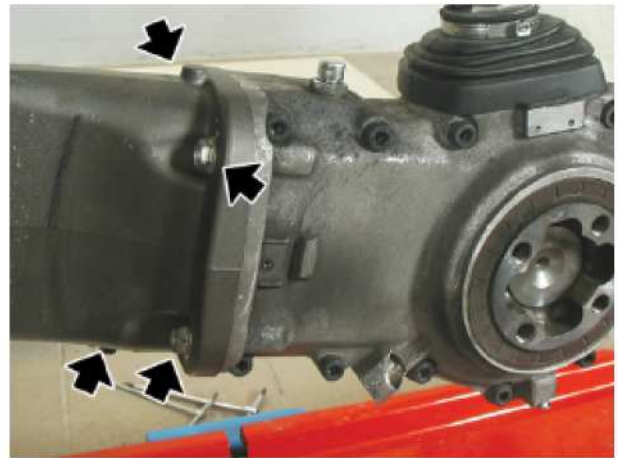
- Unscrew and remove the four screws.

Note for reassembly: Tightening torque: 50 Nm

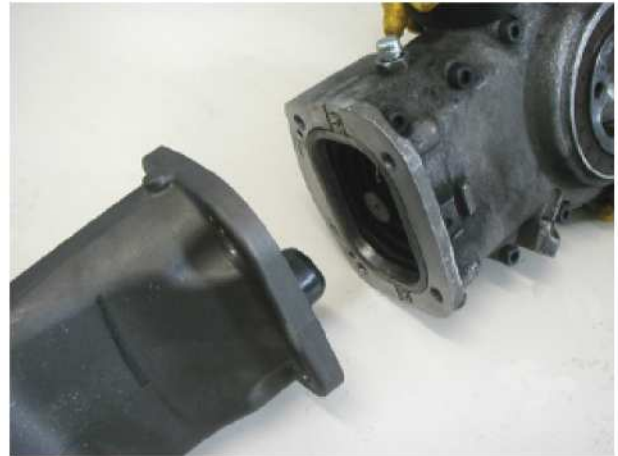
- Remove the C.A.R.C. drive assembly together with the universal joint.

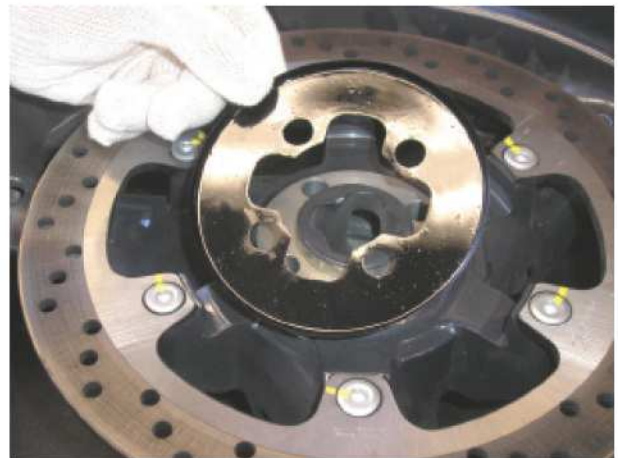
- Place the new dust seal supplied with the new drive assembly between wheel rim and universal joint; position the seal with the collar facing the drive assembly.
- Install the new drive assembly by reversing the removal procedure.

The C.A.R.C. drive assembly is supplied **DRY**.
Fill with the correct amount of transmission
fluid; see relevant manual for instructions.

Note for reassembly: Use 500cc (30.5 cu. in.) of transmission
fluid

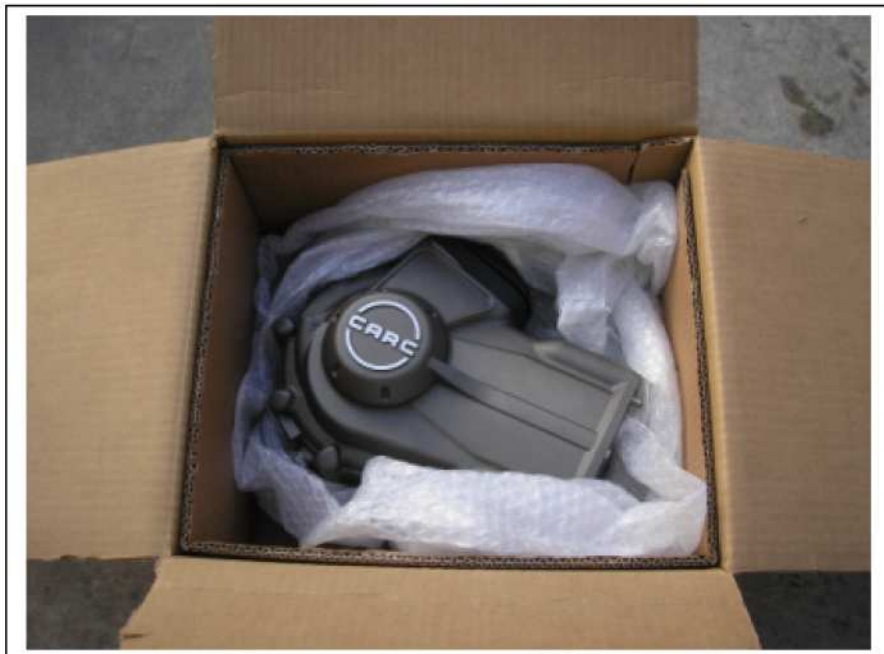
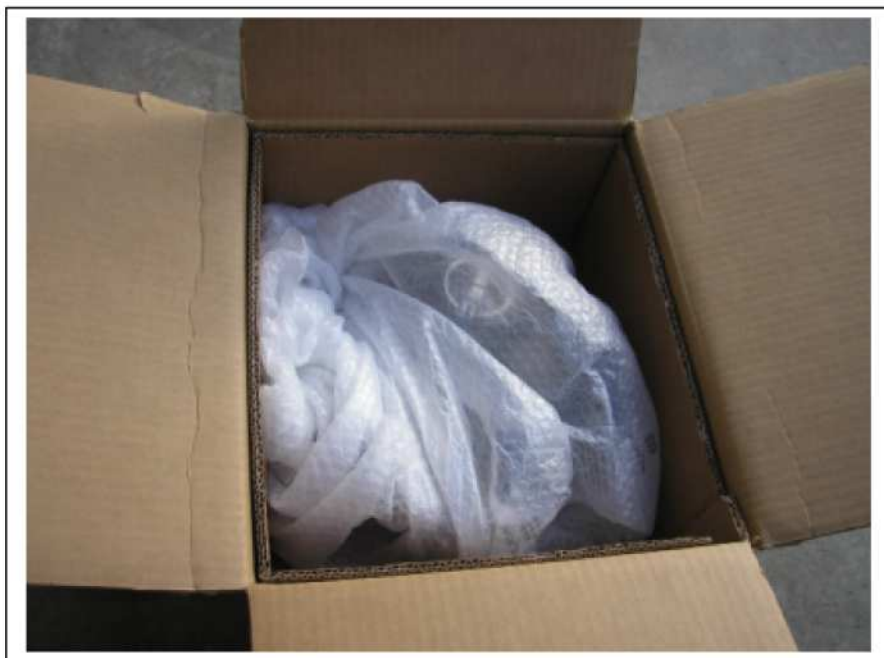
Carefully pack the drive assembly removed from vehicle - which you will have drained from oil - using the same reinforced box the new drive assembly was shipped in. Provide adequate protection from shock and damage.
